PIC16C924 Rev. A Silicon/Data Sheet Errata

The PIC16C924 (Rev. A) parts you have received conform functionally to the Device Data Sheet (DS30444E), except for the anomalies described below.

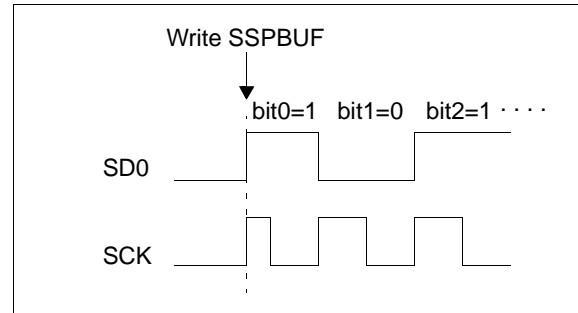
FIGURE 1: SCK PULSE VARIATION USING TIMER 2/2

When the SPI is using Timer2/2 as the clock source, a shorter-than-expected SCK pulse may occur on the first bit of the transmitted/received data (see Figure 1).

To avoid producing the short pulse, turn off Timer2 and clear the TMR2 register, load the SSPBUF with the data to transmit, and then turn Timer2 back on. Refer to Example 2 for sample code.

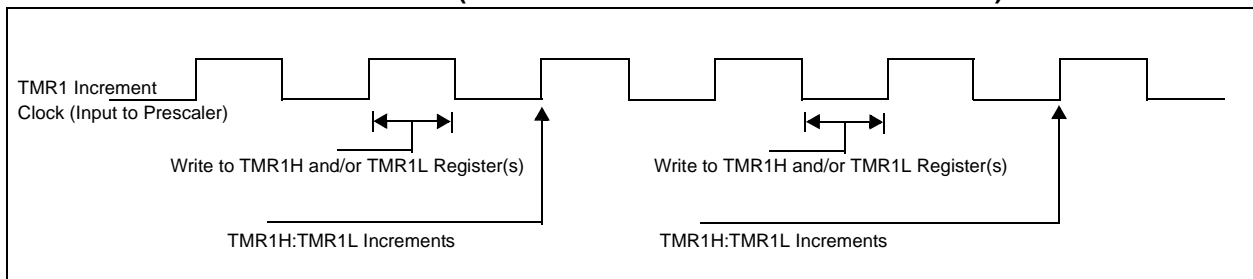
FIGURE 1: WRITES TO TIMER1 (EXTERNAL CLOCK / OSCILLATOR MODE)

The operation of Timer1 needs some clarification when the timer registers are written and the TMR1ON bit is set.

The internal clock signal that is the input to the TMR1 prescaler affects the incrementing of Timer1 (TMR1H:TMR1L registers and the Timer1 prescaler). When the Timer1 registers are NOT written, the Timer1 will increment on the rising edge of the TMR1 increment clock.

When the TMR1H and/or TMR1L registers are written while this clock is high, TMR1 will increment on the next rising edge of this clock.

When the TMR1H and/or TMR1L registers are written while this clock is low, TMR1 will not increment on the next rising edge of this clock, but must first have a falling clock and then the rising clock for TMR1 to increment.

Figure 1 shows the two cases of writes to the TMR1H and/or TMR1L registers. Due to the V_{IH} and V_{IL} thresholds on the oscillator/clock pins, external Timer1 oscillator components, and external clock frequency, the Timer1 increment clock may not be of a 50% duty cycle.

The TMR1 increment clock is out of phase of the T1OSO/T1CKI pin by a small propagation delay.

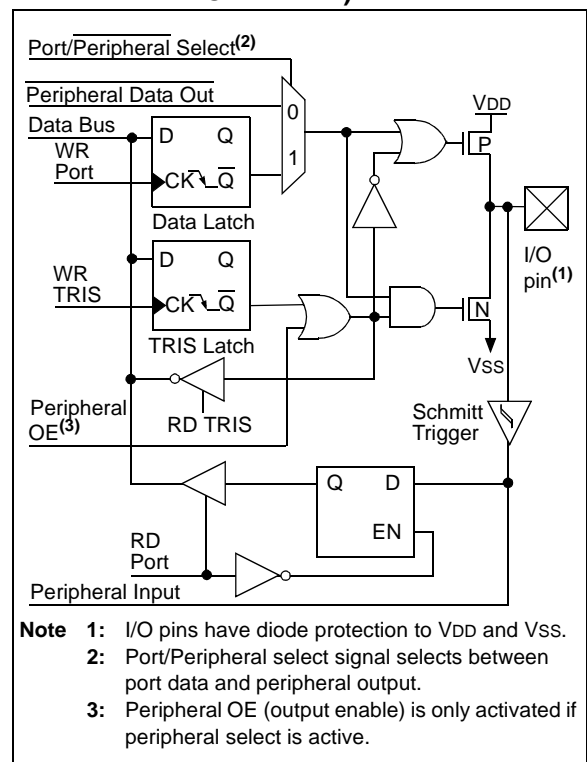
FIGURE 2: PORTC BLOCK DIAGRAM (PERIPHERAL OUTPUT OVERRIDE)

The block diagram for PORTC presented in Figure 5-5 of the Device Data Sheet (DS30444E) is incorrect. The correct block diagram is shown in Figure 2.

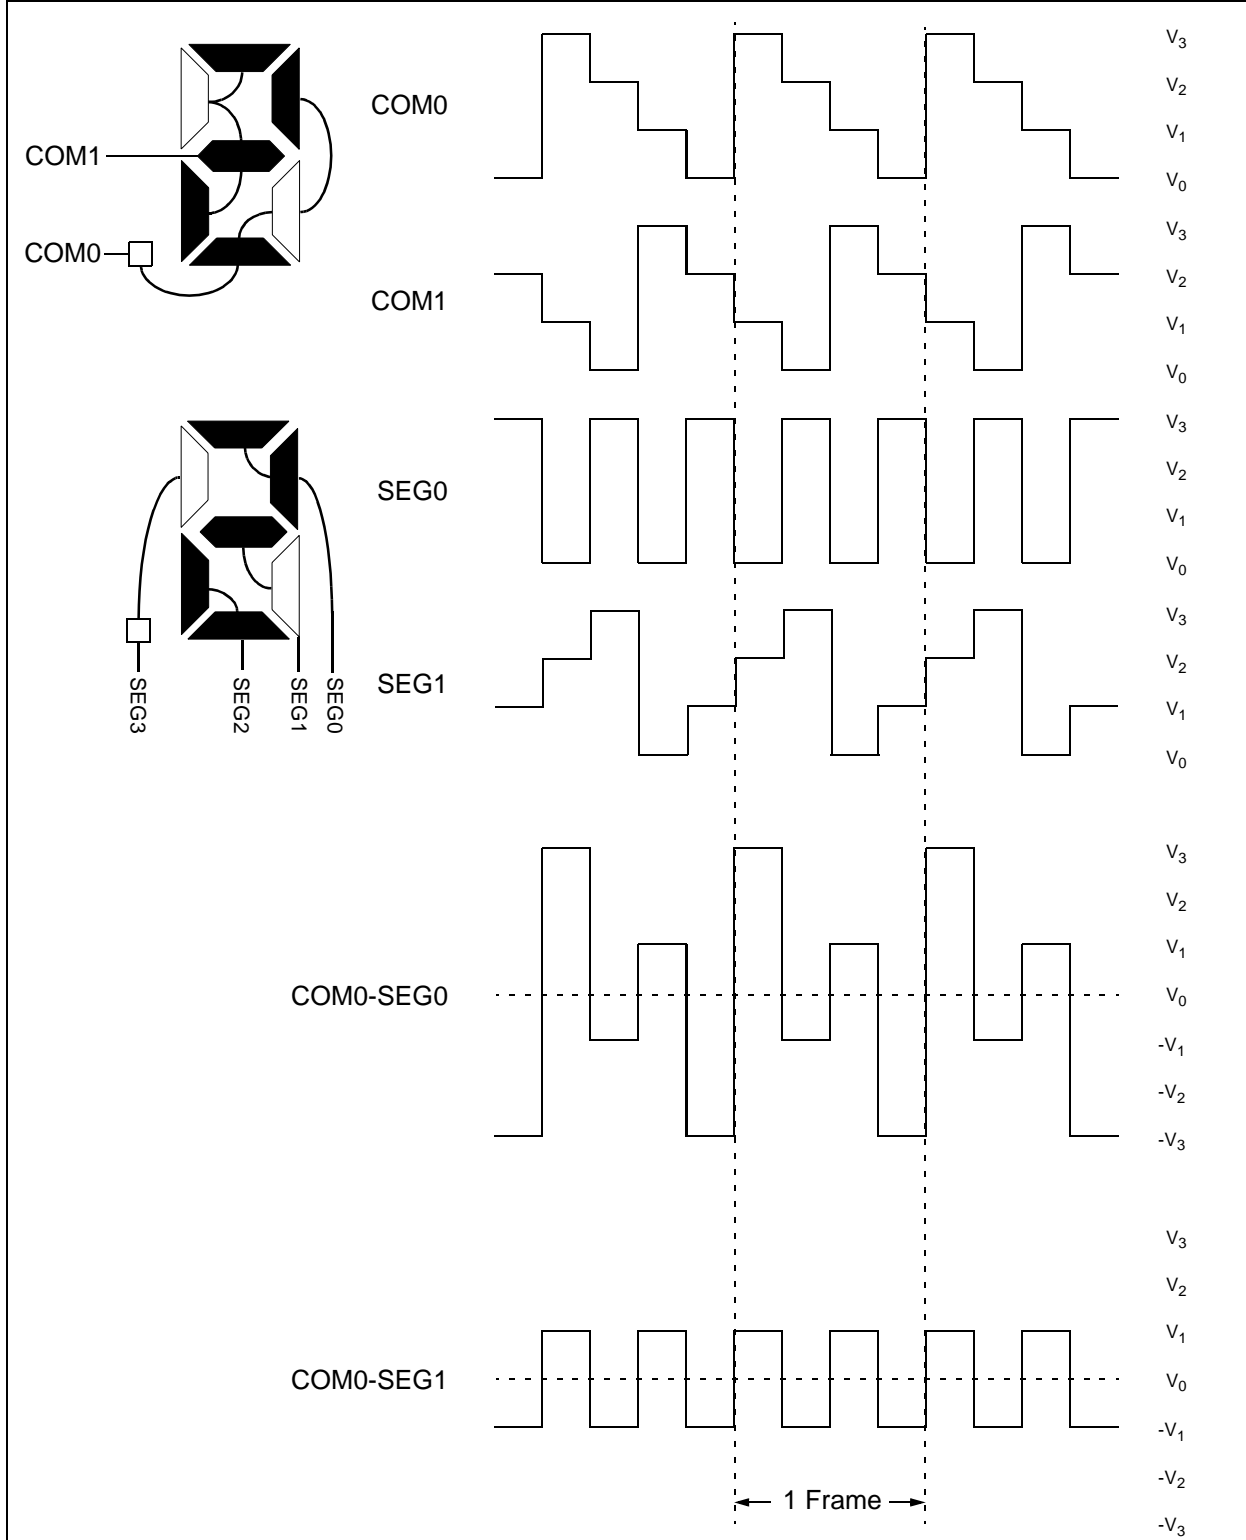
FIGURE 3: WAVEFORMS IN 1/2 MUX, 1/3 BIAS DRIVE

Figure 13-5 in the data sheet, depicting drive waveforms in 1/2 multiplex, 1/3 bias mode, is incorrect. Specifically, the connections for the

different LCD segments (SEG0 through SEG4) and the SEG1 drive waveform have been changed. The correct diagrams and waveforms are shown in Figure 3.
